DAMAGE ASSESSMENT FORM

Building Name KROME RESIDENCE

Address 17845 S.W. 296 STREET

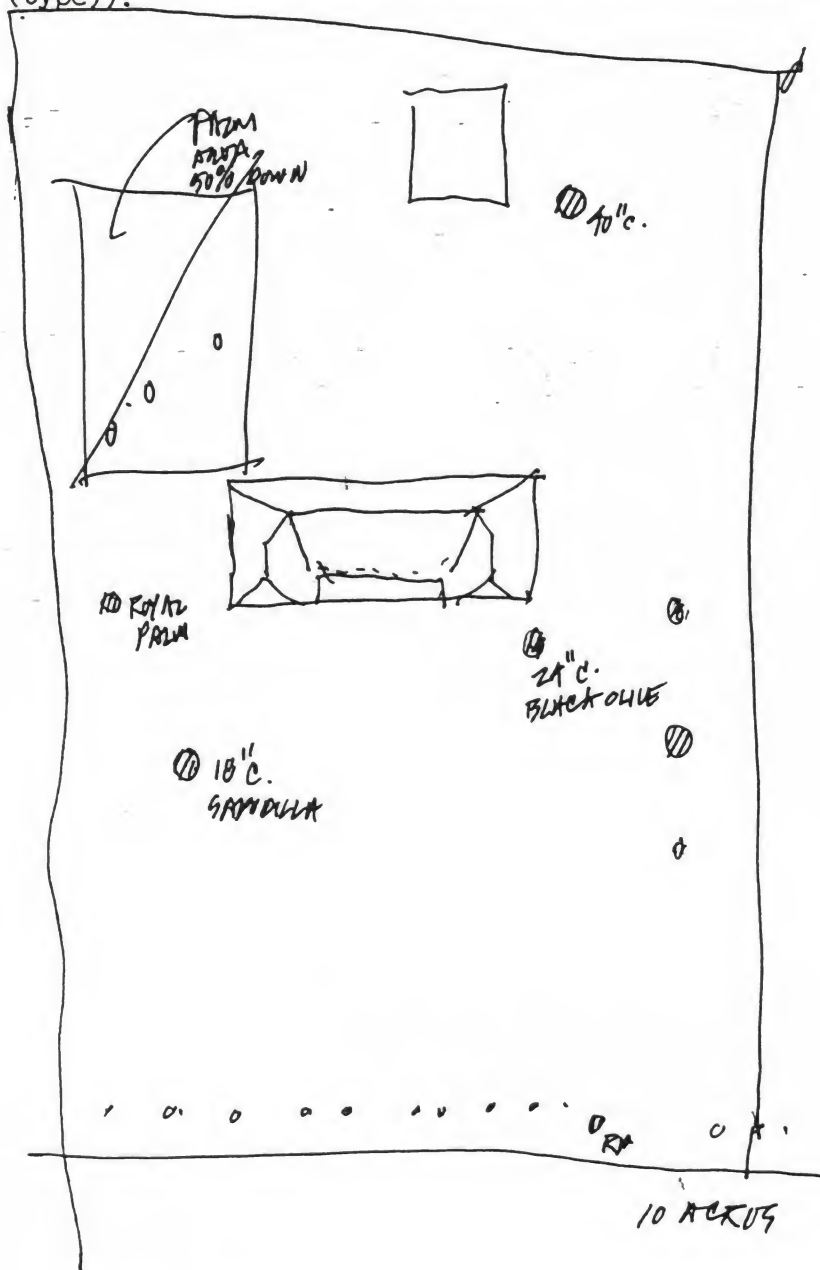
Site Sketch:

LANDSCAPE LOSS
INCLUDES MANY VARIETY OF PALMS
AVOCADO : MANGO
